SUBJECT: LA-6 Model

DATE: March 1 , 1934

This Bulletin supplies detailed supplementary information to that issued in Machine Service Bulletins No. 161, Supplements A, B, C and D, and 165, 167 and 177.

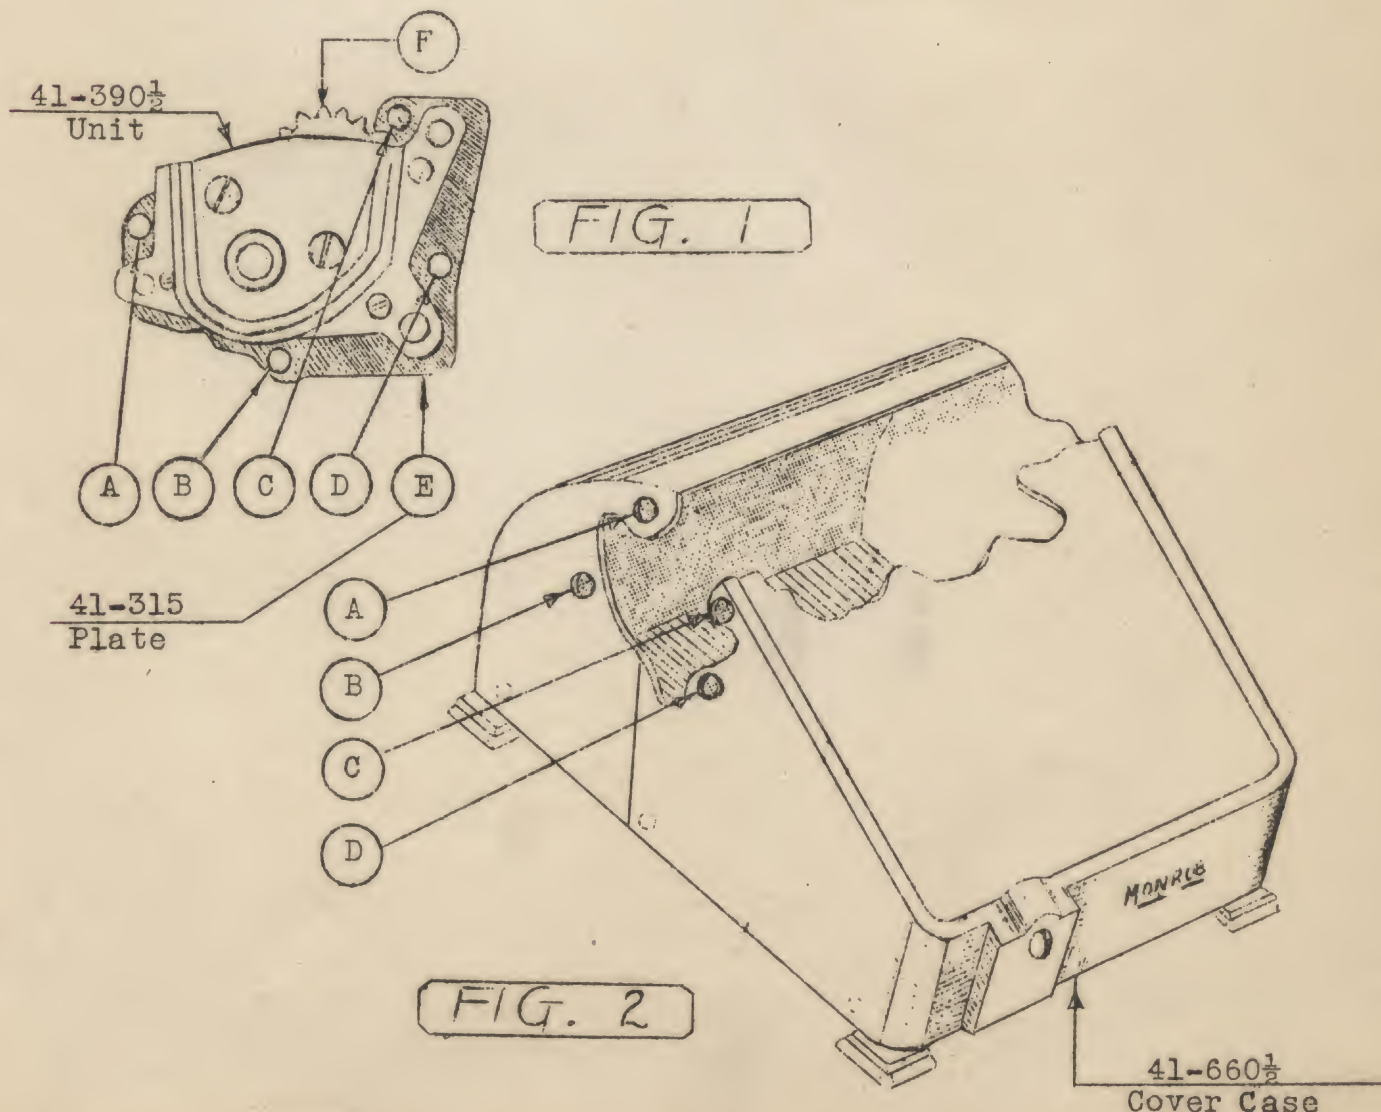
The fastening of the machine cover case, 41-660 $\frac{1}{2}$, to the through carry unit, 41-390 $\frac{1}{2}$, with screws 50506 through holes (A), (B), (C) and (D) may disturb the correct alignment of the extreme left hand extra carry gear (F) with the intermediate gears. This is due to the strain set up by the tightening of these screws. Machines in perfect operating condition often function improperly on account of this. Therefore, the use of shim washers between the end plate (E) and the cover case was resorted to. However, a change has been made in the cover case which eliminates holes (A), (B), (C) and (D) and omits the use of screws 50506.

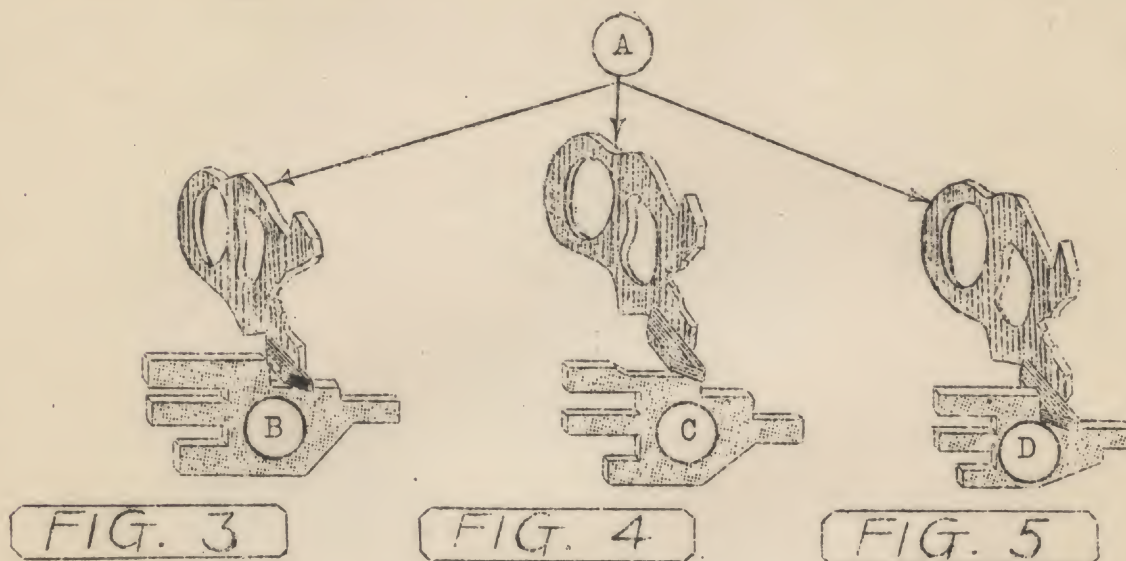
An improvement has been made in the carrying dogs by adding a small amount of stock on the top of the dogs at the points where they contact the feet of the wedges. See (B) and (D), Figure 6. In LA-6 models, due to the use of round tooth gears in the extra carry unit, it is necessary to set a slightly higher mesh between the dial gears and intermediate gears than in other L models. This higher mesh causes the wedges (A) to be depressed slightly later by the carrying pins than with the deep mesh, and we have found that this delay, even though it is slight, causes the wedges, when they are depressed, to strike the top of the dogs rather than to drop in front of them. In order to overcome this condition, we have added a small amount of metal to the top of the dogs so that the delay in depressing the wedge is compensated.

Figure 3 illustrates the correct engagement of wedges (A) with the new style 2416 dogs (B).

Figure 4 shows the incorrect condition caused by the wedges (A) dropping late and riding on top of the 2416 old style dogs (C).

Figure 5 illustrates the correct engagement of the wedges (A) with the new style 2417 dogs (D).

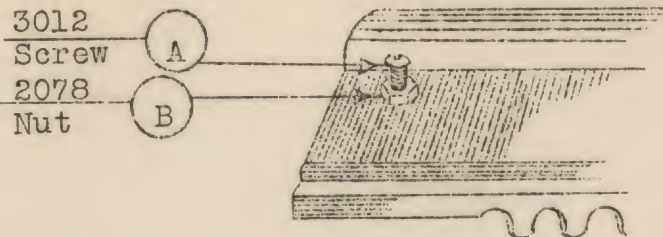
FIG. 7

Set screw (A) has been provided to limit the movement of the trip rod (H) when the constant key is depressed.

If the correct number is not registered when setting the constant into the carriage and the machine is without this feature, install screw (A) and nut (B) by following the instructions listed below. NOTE: After installing screw (A) and nut (B), if the correct number does not register when setting the constant into the carriage, adjust screw (A) up or down until the trouble is corrected.

- 1 - Position the rocker arm assembly (D), as shown. Raise stud (C) with the fingers as far as possible. In doing so, lug (F) contacts the carriage case (E) and leaves a slight mark as indicated by (G).
- 2 - Center punch this mark.
- 3 - Drill a hole through the case with a #50 drill, using the center punch indent as a guide.
- 4 - From the outside of the case enlarge the hole with a #49 drill and tap it with a 2-64 tap.
- 5 - Install nut (B) on screw (A) and insert (A) in the case to suit and tighten (B) securely.

NOTE: To allow for free movement of rocker arm (D) after installing screw (A), it may be necessary to grind (D) at (F).

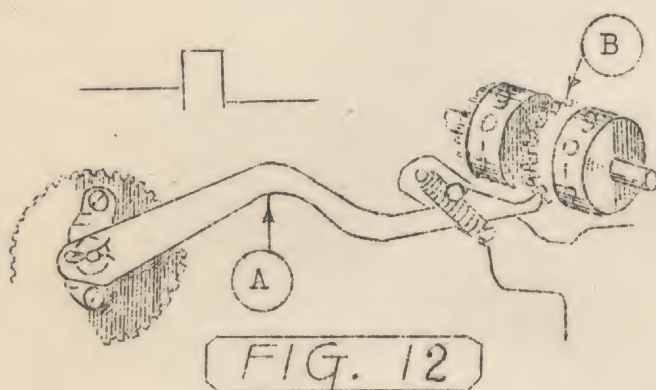
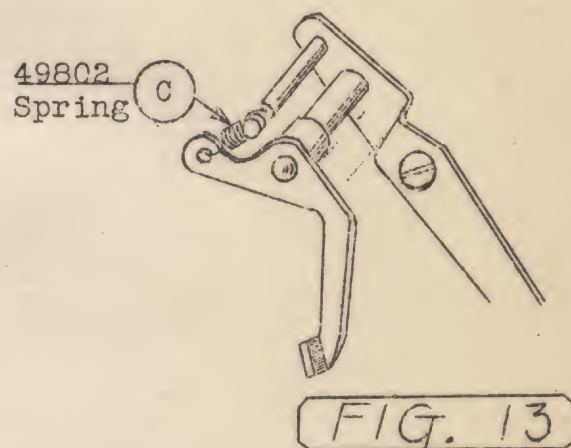
If a "1" is left in the multiplication counting dial, arm (A) is not in correct adjustment with (B), or spring (C), 49802, is too strong.

If, after the multiplication counting dial has been returned to zero the machine continues to run in the forward direction, or if the machine continues to run in a forward direction when the carriage shifts to either of the first two column, (D), Plate 8, is not adjusted close enough to the carry pin. NOTE: Whenever changing this adjustment, it is necessary to change the adjustment of (H) by bending (G). See Plate 8.

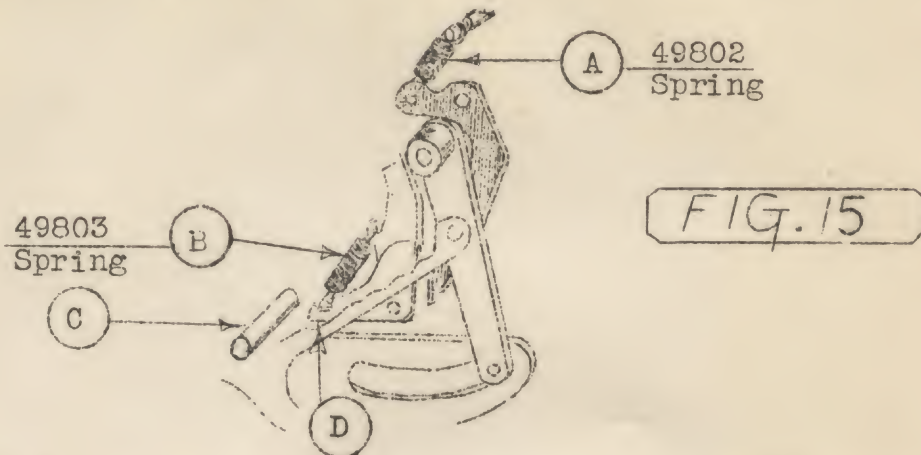
If the mechanism trips and shifts before the multiplication counting dial comes to zero, ascertain if spring (B) is too strong. If so, it should be weakened. If this does not remedy the trouble, spring (A) should be strengthened. However, if (A) is too strong, the figure "1" will be left in the same dial after multiplication. If adjusting the spring tension of these two springs does not remedy the trouble, the clearance (J), Plate 8, should be increased.

If a machine makes one or more reverse cycles after shifting in multiplication, latch (D) is adjusted too far from pin (C), or there is too much clearance at (J), Plate 8.

If the machine continues to run forward after the carriage has shifted to the first column in multiplication, pin (G) on end of the division lever is not properly adjusted by the division lever click (J) in relation to latch (H), to reset the clutch yoke trip arm to neutral.

If the machine should shift and stop in either multiplication or division, (F) is not properly adjusted to (E).

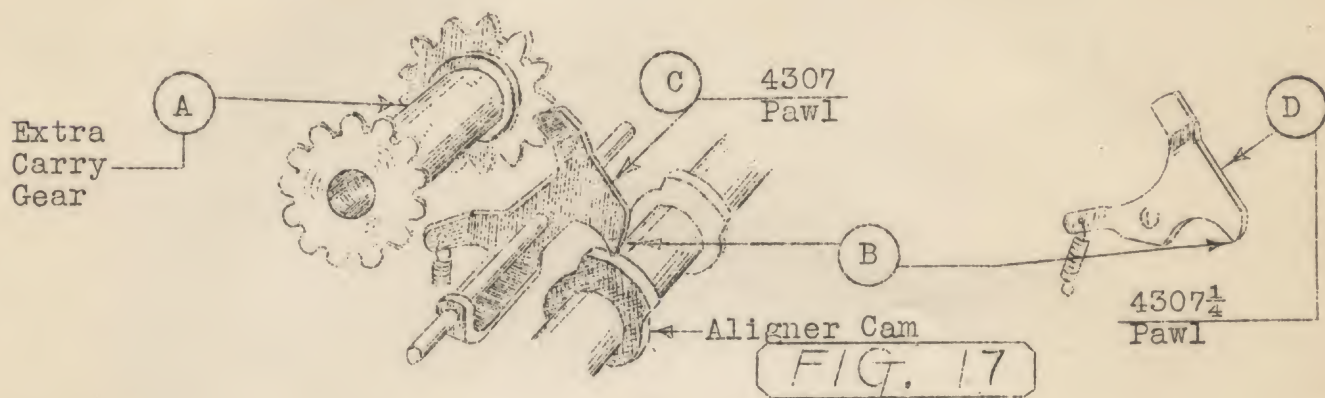
When the aligner cams are in position to lock the pawls, the extra carry gears should have a very slight amount of play. To overcome a condition whereby too much clearance exists at this point, peen the pawl (C) or (D) at (B) to suit. In some cases the installing of new pawls may remedy this condition.

Often, binds in the extra carry gears (A) are the cause of the unit locking up. Therefore, it is advisable to determine the freedom of these gears by disengaging pawls (C) and (D) from them.

A condition occurs occasionally wherein one of the pawls (C) is locked against the extra carry gear before the cam (E) on the 41-732 of the carry shaft has positioned pawl (H) into full engagement with the First extra carry gear (G). To remedy such a condition bend lug (F) slightly forward or rearward to hasten its engagement with (E) in accordance with the direction in which the machine was operating when this trouble occurred.

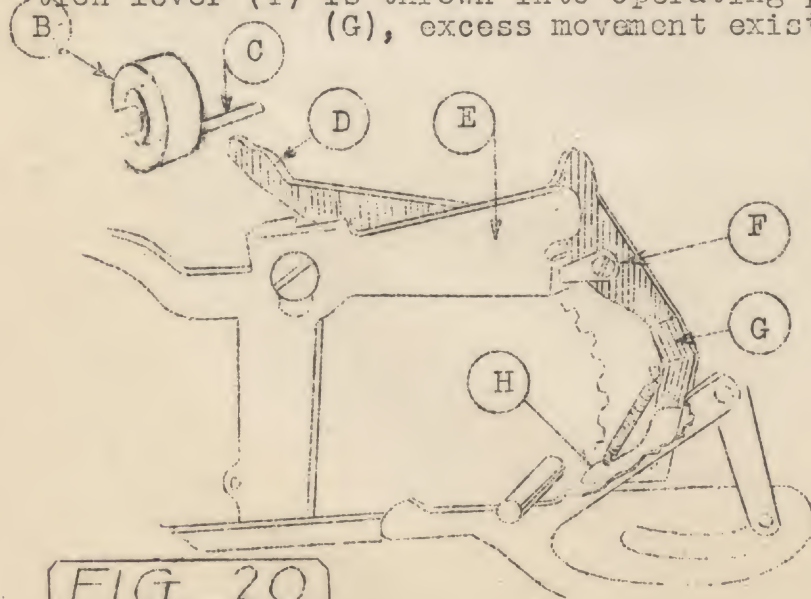
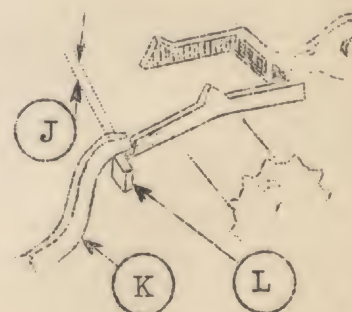
FIG. 21

The eccentric screw stud (E) on Plate 9, should be adjusted so that roller (Q) does not contact the aperture in link (F) when slide (G) is unlatched from (P). Machines not equipped with a 49105 stopping blank shown as (M), should have this feature installed. After installing blank (M), neutralize the division and multiplication levers and adjust blank (M) to the end of link (F) so that .015 clearance exists at (U). After the proper adjustment has been made, tighten the tie rod screw (N) securely. To test this adjustment throw the division lever in and snap it out of the divide position. When it is restored to neutral, link (F) should not contact roller (Q) enough to cause any upward movement of (G).

Screw (R) should be adjusted in slot (S) so that when the multiplication lever (T) is thrown into operating position and roller (Q) raises (G), excess movement exists after (G) latches on (P).

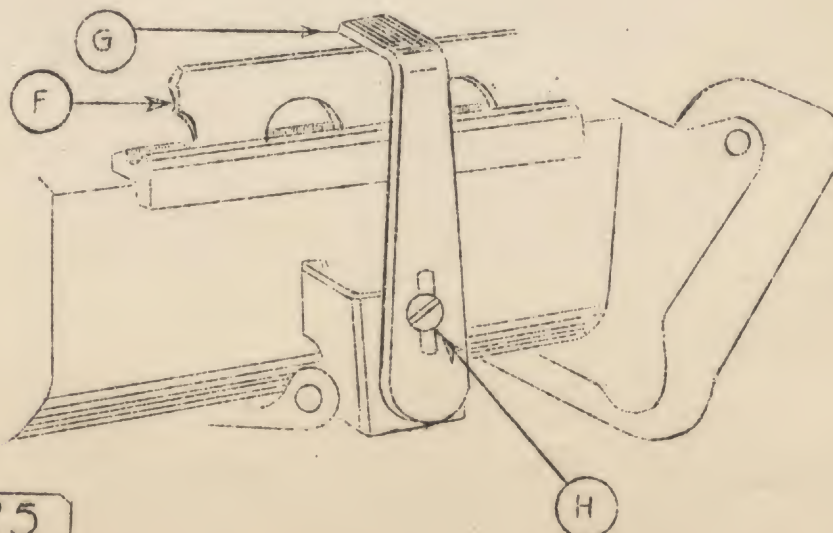
FIG. 25

The unit carriage lock (G), if distorted, may not function properly in relation to the carriage lock ledge (F). This should be corrected by readjusting (G) to (F) and tightening screw (H) securely. It is advisable to check the lock for free movement without spring tension.

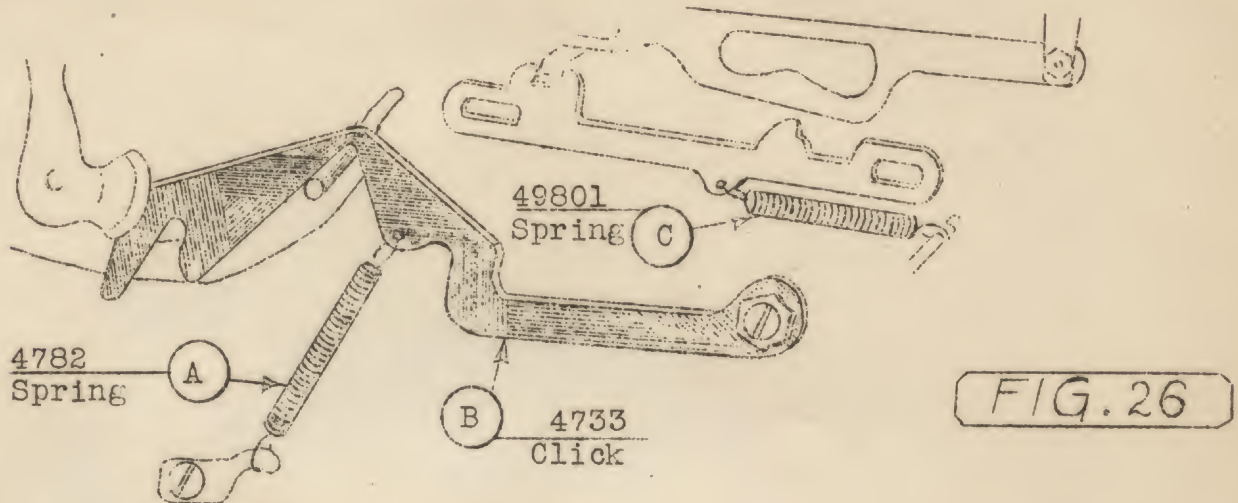
The new style division lever click (B) should be installed in all machines. (See Machine Service Bulletin No. 161-B, Plate 28.) Upon installing the new click it is important that spring (A), 4782, is of standard length and tension. Therefore, if the original spring has been shortened, replace it. It is also necessary to replace (C), 49801, with a 788 spring.

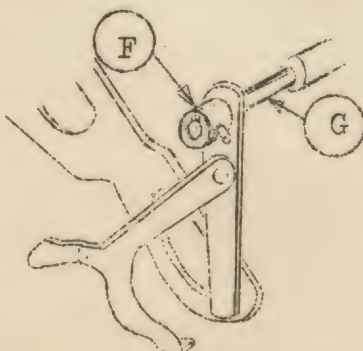
Ascertain that the right hand ends of hub (F) and shaft (G) do not interfere with the cover case, 41-660. To remedy this condition grind the face of hub (F) and shaft (G).

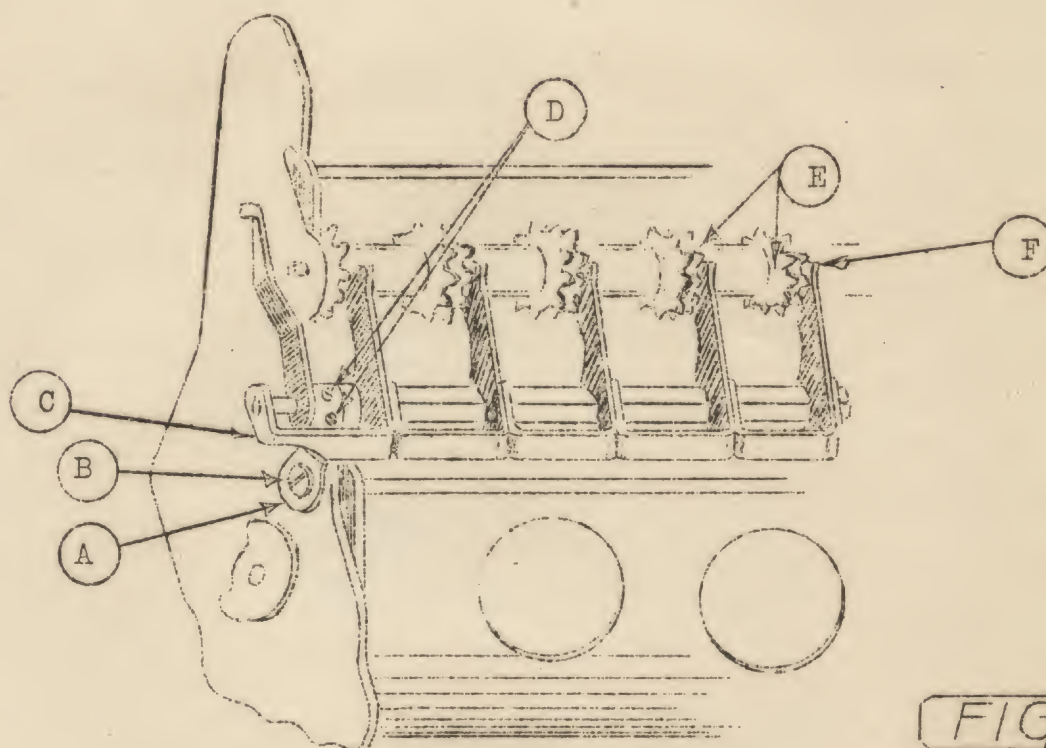
If at the end of subtraction in automatic division, or at the end of the forward correction cycle, the machine should continue to run, trip levers (F) are adjusted too low.

If in automatic division, the machine should reverse itself before the division is complete in a column, the trip levers (F) are adjusted too high.

The points of trip levers (F) should extend slightly below the surface of the teeth on gears (E). Holding the points at this position, loosen (B) and place blank (A) up against the fold of arm (C) and tighten screw (B) securely. Loosen screws (D) and position arms (F) upward or downward in relation to the regular trip lever. After the desired adjustment has been made tighten screws (D) securely.
